**Flood Control Project Maintenance  
Levee Inspections**

**Spring 2014 Levee Inspection Results**

**Madera County FCWCA**

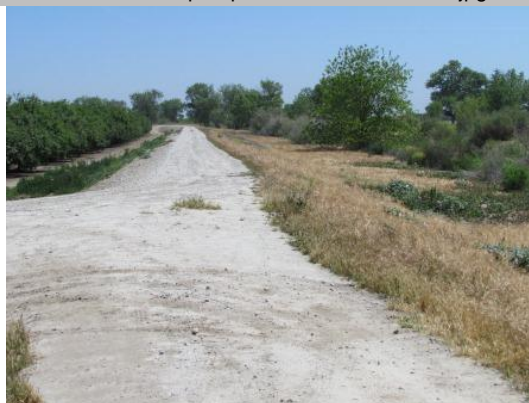
Photo 1 of 1 : phillips\_s\_20140501\_05817.jpg

Ash Slough Unit 1 looking upstream at waterside levee mile 0.00, both slopes are covered with wild weeds. Photo taken 4-29-2014.

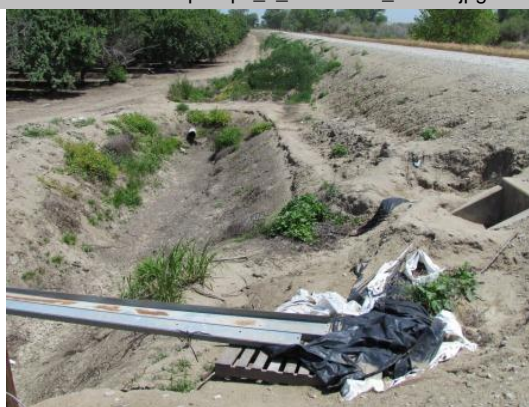
Photo 1 of 1 : phillips\_s\_20140501\_05818.jpg

LM Start	0.02	Rating **	U	Issue No.	18
LM End	0.05	Issue Type +	En	Location *	LS
Category	Earthen Levee			GPS Latitude/Longitude	
				Start	End
Item	Encroachments			37.046566 °	37.046715 °
				-120.427512 °	-120.426964 °
DWR ID	DWR_NA0011_01_s _ 2014_18				
Action/Comments					
Ditch					
Inspector Comments: There seem to be lots of activity going on at this location. Ths ditch will cause more damage to the levee slope and toe.

Irrigation ditch within the landside levee toe. Photo taken 4-29-2014.

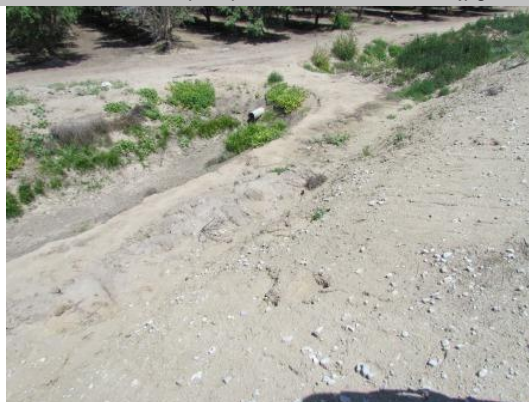
Photo 1 of 1 : phillips\_s\_20140501\_05819.jpg

LM Start	0.03	Rating **	U	Issue No.	20
LM End	0.04	Issue Type +	Ma	Location *	LS
Category	Earthen Levee			GPS Latitude/Longitude	
				Start	End
Item	Slope Stability			37.046624 °	37.046682 °
				-120.427317 °	-120.427108 °
DWR ID	DWR_NA0011_01_s _ 2014_20				
Action/Comments					
Repair slope instability. Inspector Comments: This is not a new erosion site, it should be repaired before the condition get any worse.

The landside levee slope and toe has some damage noted during this inspection. Photo taken 4-29-2014.

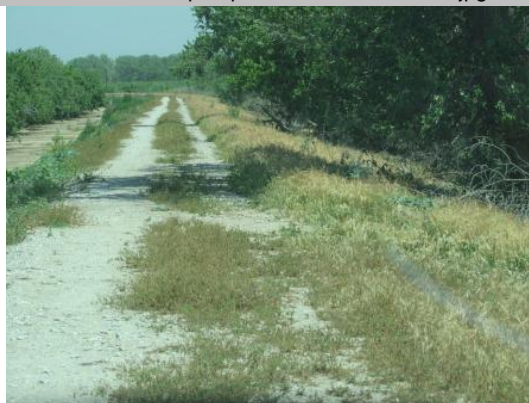
Photo 1 of 1 : phillips\_s\_20140501\_05820.jpg

The levee crown roadway is overgrown with weeds. Photo taken 4-29-2014.

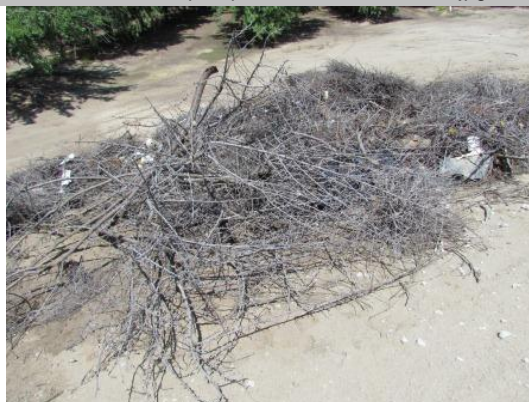
Photo 1 of 1 : phillips\_s\_20140505\_05821.jpg

Unauthorized stock pile of tree cuttings on the landside levee toe. Photo taken 4-29-2014.

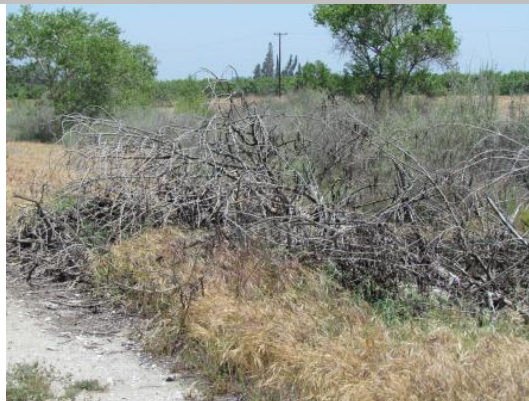
Photo 1 of 1 : phillips\_s\_20140505\_05822.jpg

This dead tree has not been removed from the levee section, the shoulder slope and toe is blocked. Photo taken 4-29-2014.

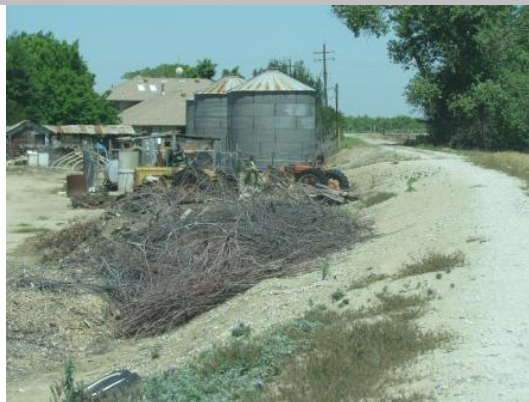
Photo 1 of 1 : phillips\_s\_20140505\_05825.jpg

Unauthorized brush pile on the landside toe and slope of the levee section. Photo taken 4-29-2014.

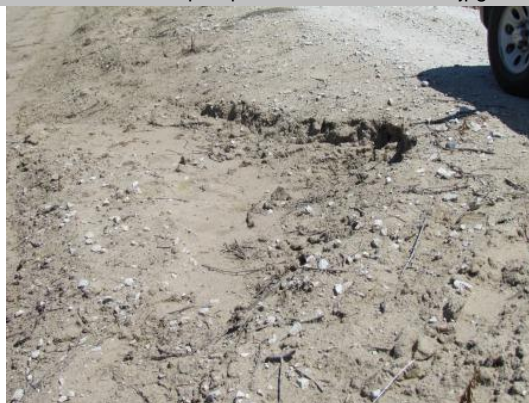
Photo 1 of 1 : phillips\_s\_20140505\_05823.jpg

LM Start	0.99	Rating **	U	Issue No.	30
LM End	0.99	Issue Type +	Ma	Location *	LS
Category	Earthen Levee			GPS Latitude/Longitude	
				Start	End
Item	Slope Stability			37.055703 °	37.055703 °
				-120.415603 °	-120.415603 °
DWR ID	DWR_NA0011_01_s _ 2014_30				
Action/Comments					
Repair slope instability. Inspector Comments: Damage caused by farmer irrigating the almond orchard.

The levee slope has been damaged by the farmers, material has been washed away from irrigation pipe across levee crown roadway. Photo taken 4-29-2014.

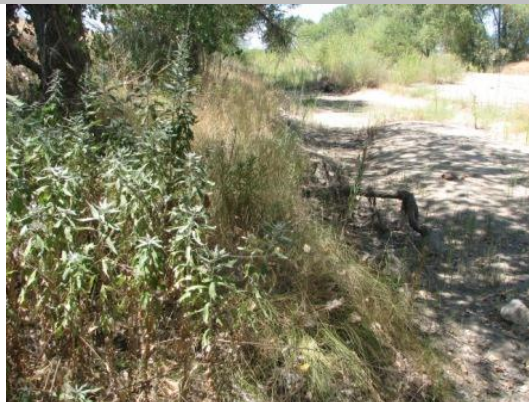
Photo 1 of 2 : phillips\_s\_20140414\_670.jpg

LM Start	1.11	Rating **	M	Issue No.	1
LM End	1.20	Issue Type +	Ma	Location *	WS
Category	Supplemental			GPS Latitude/Longitude	
				Start	End
Item	DWR Erosion Survey			37.055596 °	37.055596 °
				-120.412647 °	-120.412647 °
DWR ID	DWR_NA0011_01_s _ 2013_1				
Action/Comments					
Inspector Comments: 07/31/2012: Site was visited on 07/24/2012. No significant change observed. Dense vegetation around the site 08/09/2011: Site was inspected. No visible change was observed from the previous condition. A fallen tree was seen at the levee toe about 20 feet upstream, and tree root exposed. There has been no report from the district that this site was corrected. 11/30/2010: Site was not inspected due to time constraints. There have been no reports from the district that the site was corrected. Continue to monitor site during flood events. 08/05/2010: Recommended for annual assessment and monitoring during flood events, per CLRO. 2009: Site is recommended as a local maintenance issue, per Critical Levee Repair Office, Critical Erosion Sites Evaluation 2008 Report; site was previously rated "M" 9/6/2007: Undercutting of the toe; several trees along the WS slope with roots exposed. [2012 Site ID:NA0011U01RM2.57]

Close-in view at the erosion site

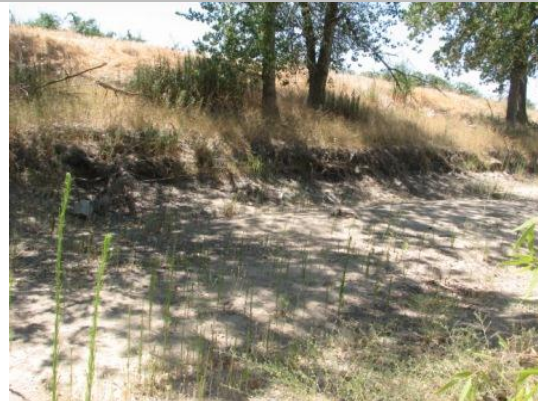
Photo 2 of 2 : phillips\_s\_20140414\_671.jpg

LM Start	1.11	Rating **	M	Issue No.	1 (cont)
LM End	1.20	Issue Type +	Ma	Location *	WS
Category	Supplemental			GPS Latitude/Longitude	
				Start	End
Item	DWR Erosion Survey			37.055596 °	37.055596 °
				-120.412647 °	-120.412647 °
DWR ID	DWR_NA0011_01_s _ 2013_1				
Action/Comments					
Inspector Comments: 07/31/2012: Site was visited on 07/24/2012. No significant change observed. Dense vegetation around the site 08/09/2011: Site was inspected. No visible change was observed from the previous condition. A fallen tree was seen at the levee toe about 20 feet upstream, and tree root exposed. There has been no report from the district that this site was corrected. 11/30/2010: Site was not inspected due to time constraints. There have been no reports from the district that the site was corrected. Continue to monitor site during flood events. 08/05/2010: Recommended for annual assessment and monitoring during flood events, per CLRO. 2009: Site is recommended as a local maintenance issue, per Critical Levee Repair Office, Critical Erosion Sites Evaluation 2008 Report; site was previously rated "M" 9/6/2007: Undercutting of the toe; several trees along the WS slope with roots exposed. [2012 Site ID:NA0011U01RM2.57]

View from the riverbed

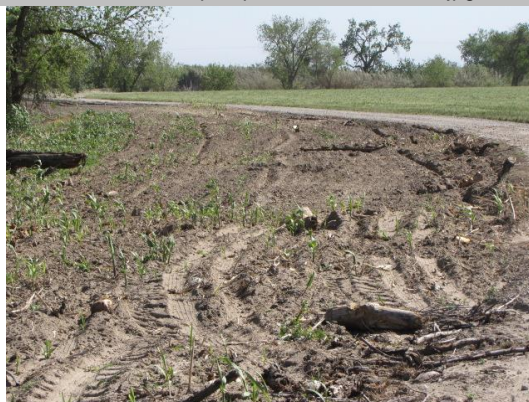
Photo 1 of 2 : phillips\_s\_20140414\_675.jpg

LM Start	2.40	Rating **	U	Issue No.	17
LM End	2.40	Issue Type +	Ma	Location *	WS
Category	Earthen Levee			GPS Latitude/Longitude	
				Start	End
Item	Slope Stability			37.068737 °	37.068737 °
				-120.398570 °	-120.396570 °
DWR ID	DWR_NA0011_01_s _ 2013_17				
Action/Comments					
Repair slope instability. Inspector Comments: The farmer has plowed up the waterside berm too close to the levee toe causing damage to the levee toe also this method transfers the Bamboo roots along the berm. Spraying is needed to kill the new growth. This method of maintaining the waterside cannot continue.

Ash Slough Levee mile 2.40 waterside berm. Farmer plowed too close.  
Damage to slope. Photo taken 4-17-2013.

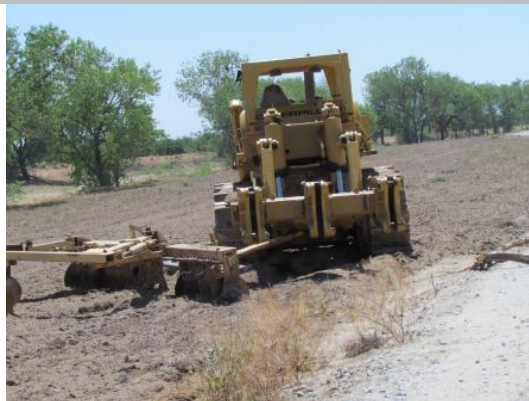
Photo 2 of 2 : phillips\_s\_20140505\_05824.jpg

LM Start	2.40	Rating **	U	Issue No.	17 (cont)
LM End	2.40	Issue Type +	Ma	Location *	WS
Category	Earthen Levee			GPS Latitude/Longitude	
				Start	End
Item	Slope Stability			37.068737 °	37.068737 °
				-120.398570 °	-120.396570 °
DWR ID	DWR_NA0011_01_s _ 2013_17				
Action/Comments					
Repair slope instability. Inspector Comments: The farmer has plowed up the waterside berm too close to the levee toe causing damage to the levee toe also this method transfers the Bamboo roots along the berm. Spraying is needed to kill the new growth. This method of maintaining the waterside cannot continue.

Ash Slough damaged levee toe, farmer plowing the berm has cut into the toe of the waterside. Photo taken 4-29-2014.

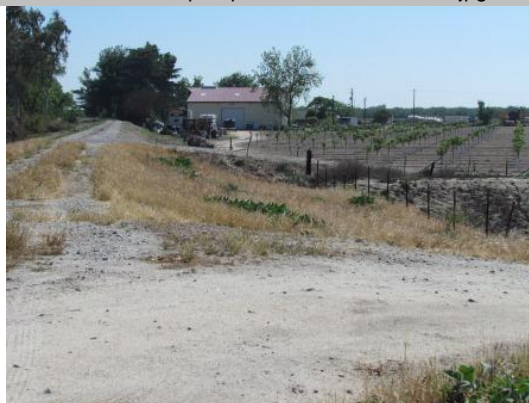
Photo 1 of 1 : phillips\_s\_20140505\_05826.jpg

Ash Slough looking upstream from levee mile 0.00 landside slope and toe overgrown with wild weeds. Photo taken 4-29-2014.

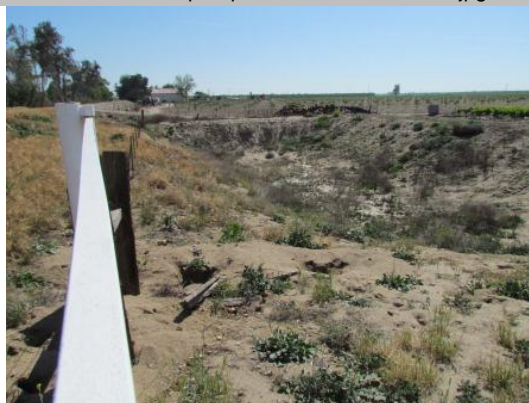
Photo 1 of 1 : phillips\_s\_20140505\_05827.jpg

Ash Slough Levee mile 0.01-0.03 settling basin on landside. First reported this issue on 2012 levee inspection. Photo taken 4-29-2014.

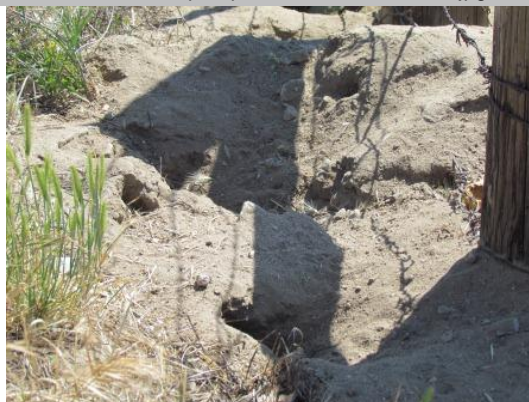
Photo 1 of 2 : phillips\_s\_20140505\_05828.jpg

Levee miles 0.05 thru 1.69 rodent activity on the landside slope and toe.  
Photo taken 4-29-2014.

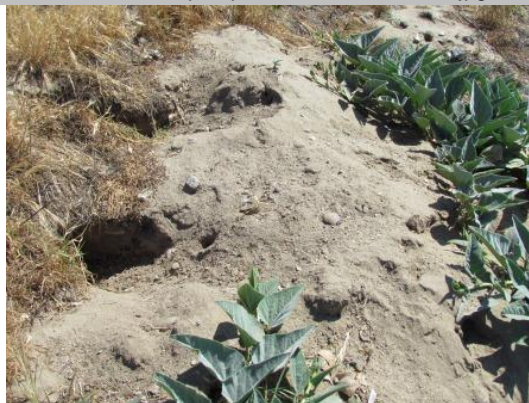
Photo 2 of 2 : phillips\_s\_20140505\_05829.jpg

Rodent activity, no rodent was seen. Photo taken 4-29-2014.

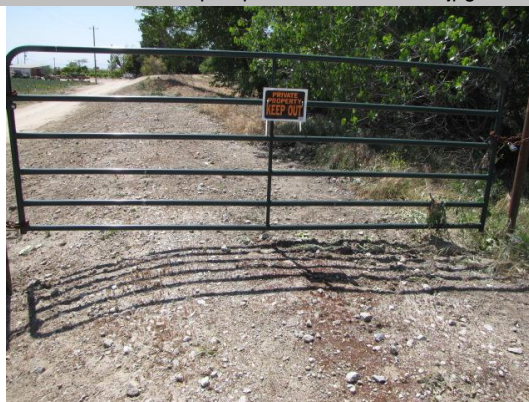
Photo 1 of 1 : phillips\_s\_20140414\_677.jpg

LM Start	0.31	Rating **	M	Issue No.	5
LM End	0.31	Issue Type +	En	Location *	CR
Category	Earthen Levee			GPS Latitude/Longitude	
				Start	End
Item	Encroachments			37.463150 °	37.046315 °
				-120.424419 °	-120.424419 °
DWR ID	DWR_NA0011_02_f _ 2012_5				
Action/Comments					
Fence					
Inspector Comments: This fence was not authorized by CVFPB. The District is aware of the fence. The landowner installed the fence and gate across the levee section because he has been broken into and into many items stolen in the past. I meet with the landowner 4-29-2014 and he let me put a State lock on his gate to gain access to the levee.

Unauthorized gate and metal fence placed on slope and toe of levee section. Photo taken 4-17-2013.

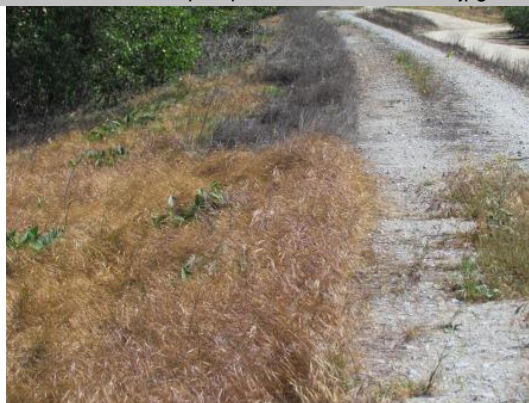
Photo 1 of 1 : phillips\_s\_20140505\_05830.jpg

Tall weeds on the waterside slope and shoulder. Photo taken 4-29-2014.

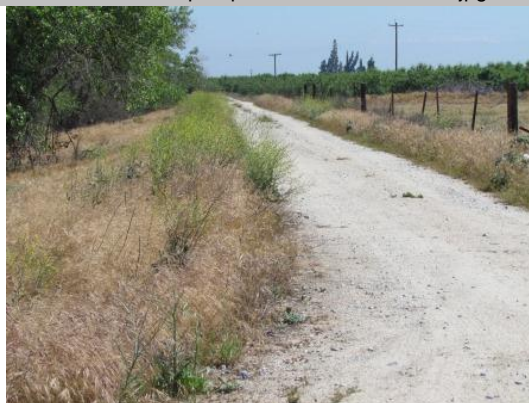
Photo 1 of 1 : phillips\_s\_20140505\_05831.jpg

Levee miles 0.33-1.55 unsatisfactory tall weeds covering the waterside levee section. Photo taken 4-29-2014.

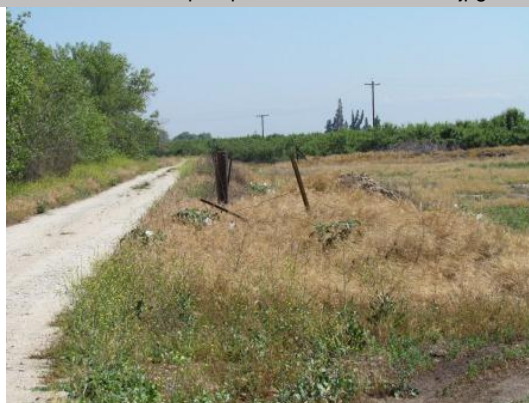
Photo 1 of 1 : phillips\_s\_20140505\_05832.jpg

Fence on landside slope. Photo taken 4-29-2014.

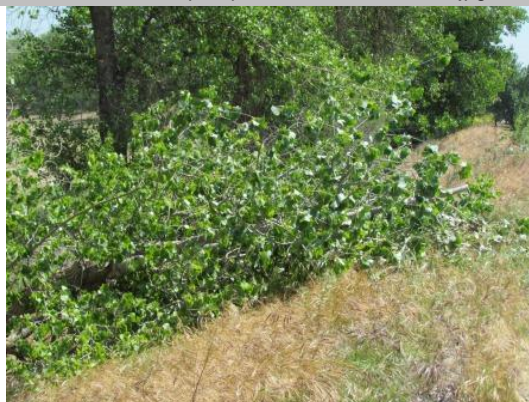
Photo 1 of 1 : phillips\_s\_20140505\_05833.jpg

Fallen tree on waterside slope blocking visibility of levee section. Photo taken 4-29-2014.

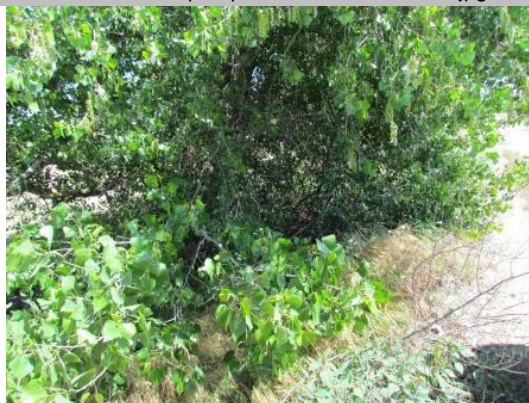
Photo 1 of 1 : phillips\_s\_20140505\_05834.jpg

Fallen tree on waterside blocked visibility of levee slope. Photo taken 4-29-2014.

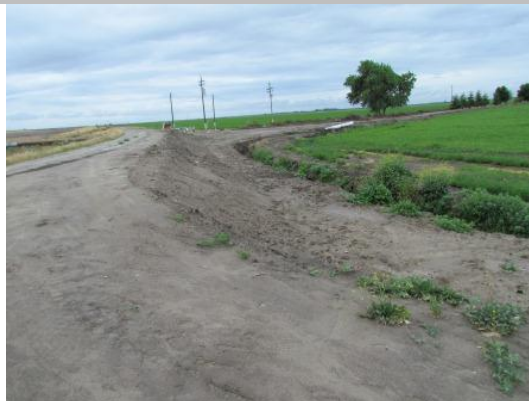
Photo 1 of 1 : phillips\_s\_20140515\_05869.jpg

Berenda Slough levee mile 0.00 looking downstream at landside slope, there is a drain ditch within 10-foot of levee toe. Photo taken 4-25-2014.

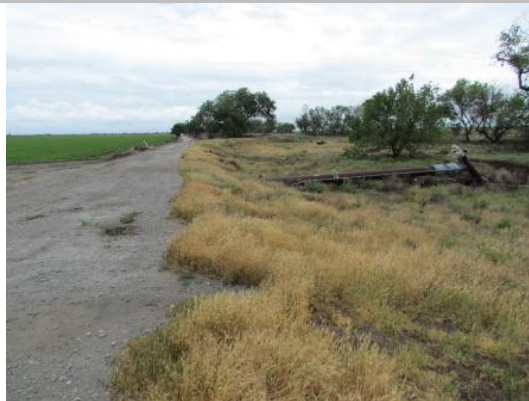
Photo 1 of 1 : phillips\_s\_20140515\_05873.jpg

Berenda Slough looking upstream from waterside shoulder levee mile 0.02. No maintenance has been done. Photo taken 4-25-2014.

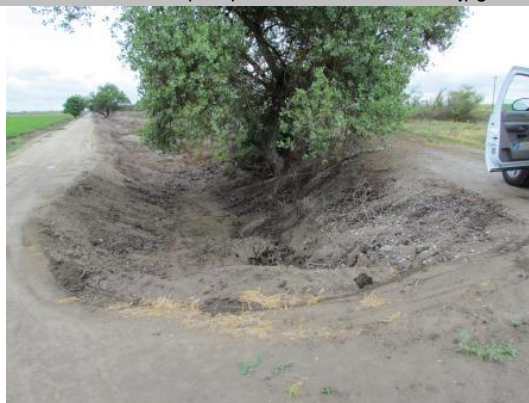
Photo 1 of 1 : phillips\_s\_20140515\_05874.jpg

This drain is used by Chowchilla Flood Control. Photo taken 4-25-2014.

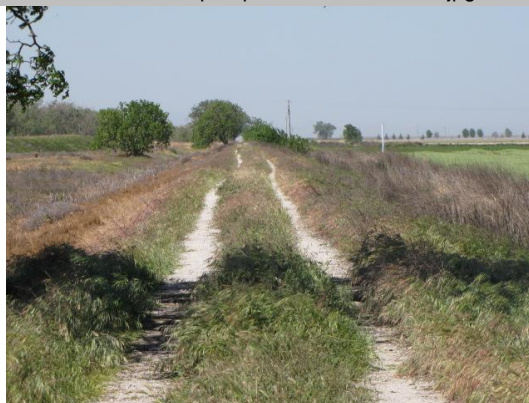
Photo 1 of 1 : phillips\_s\_20140414\_687.jpg

Berenda Slough overgrown crown roadway looking back upstream from levee mile 1.55 to 1.05. Photo taken 4-16-2013.

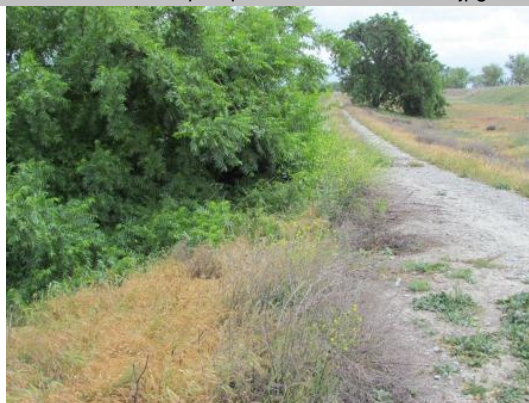
Photo 1 of 1 : phillips\_s\_20140515\_05870.jpg

This tree at levee mile completely blocks visibility of the levee slope and toe, it also extends out to the shoulder landward. Photo taken 4-25-2014.

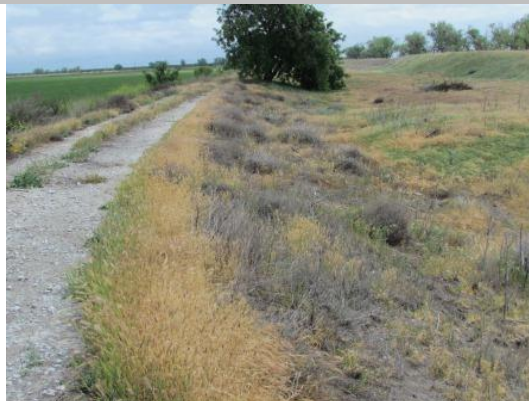
Photo 1 of 1 : phillips\_s\_20140515\_05871.jpg

Levee slope overgrown, no maintenance has been done. Photo taken 4-25-2014.

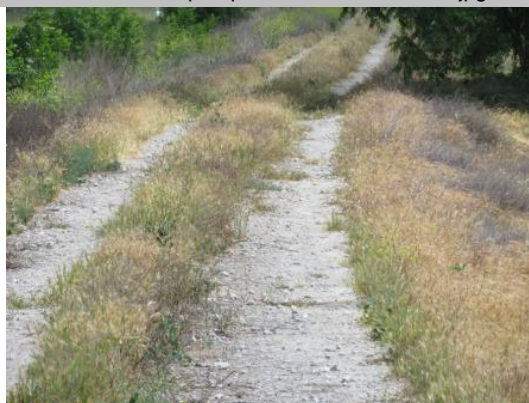
Photo 1 of 1 : phillips\_s\_20140515\_05868.jpg

Berenda Slough levee mile 1.06-1.55 weeds covering crown roadway. Photo taken 4-25-2014.

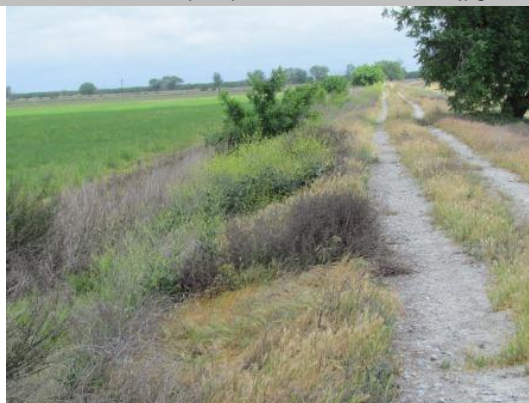
Photo 1 of 1 : phillips\_s\_20140515\_05872.jpg

Berenda Slough looking at slope from levee 1.06 upstream, wild weed taken over levee slope, shoulder and toe. Photo taken 4-25-2014.

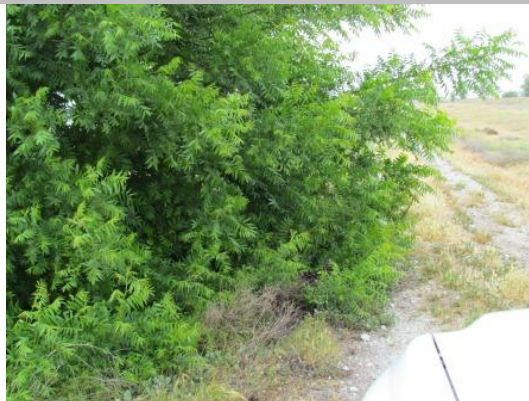
Photo 1 of 1 : phillips\_s\_20140515\_05875.jpg

Tree blocking crown, shoulder, slope and toe of the levee section. Photo taken 4-25-2014.

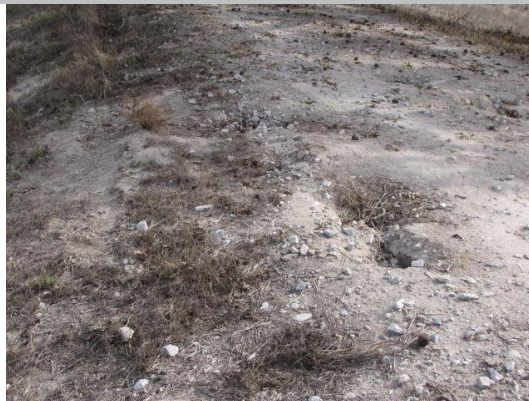
Photo 1 of 3 : phillips\_s\_20140414\_681.jpg

There are several rodent holes in the shoulder and crown of the roadway.

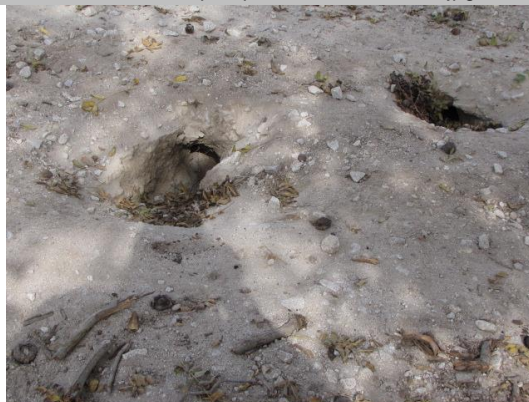
Photo 2 of 3 : phillips\_s\_20140414\_682.jpg

This photo shows holes in crown and shoulder.

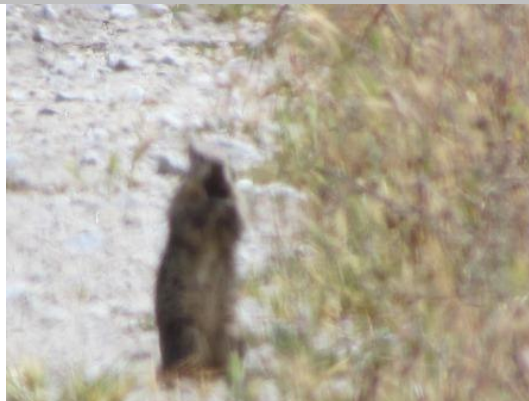
Photo 3 of 3 : phillips\_s\_20140515\_05876.jpg

Captured photo of Rodent leaving the burrow in the crow roadway.  
Photo taken 4-25,-2014.

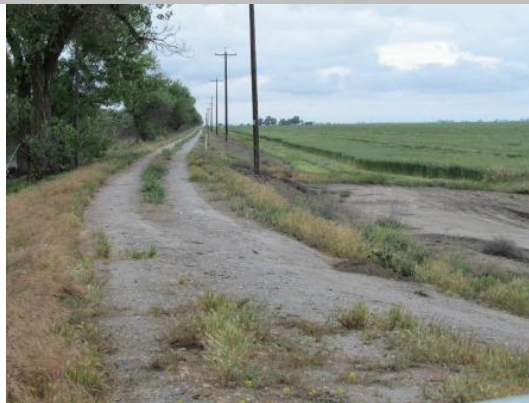
Photo 1 of 1 : phillips\_s\_20140428\_05806.jpg

Berenda Slough looking upstream from landside slope, unsatisfactory wild growth covering the slope Unit 4. Photo taken 4-24-2014.

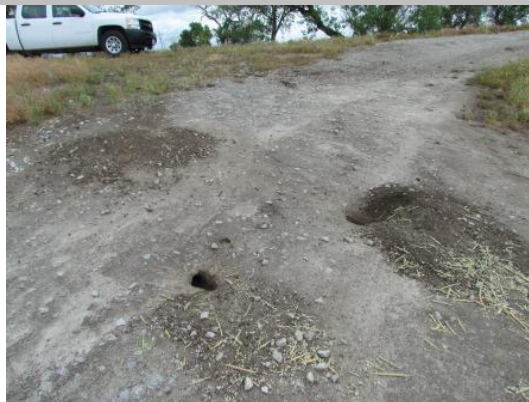
Photo 1 of 2 : phillips\_s\_20140428\_05808.jpg

Large rodent holes on landside slope looking upstream from levee mile 0.01. Photo taken 4-24-2014.

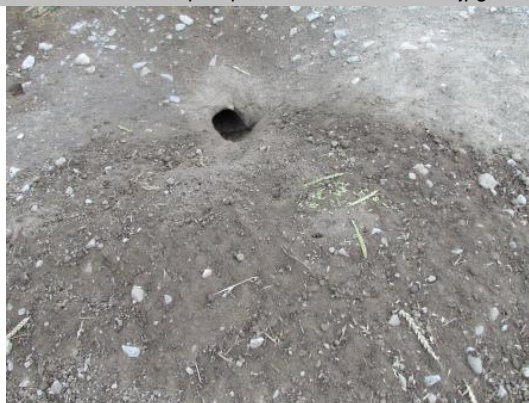
Photo 2 of 2 : phillips\_s\_20140428\_05809.jpg

Large rodent hole on landward slope levee mile 0.01. Photo taken 4-24-2014.

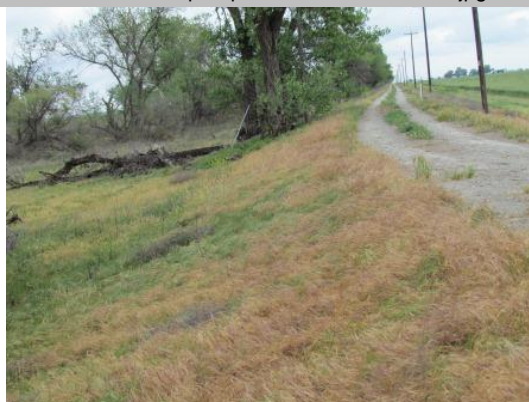
Photo 1 of 1 : phillips\_s\_20140428\_05807.jpg

Berenda Slough looking upstream from levee mile 0.03 waterward slope Unit 4. Photo taken 4-24-2014.

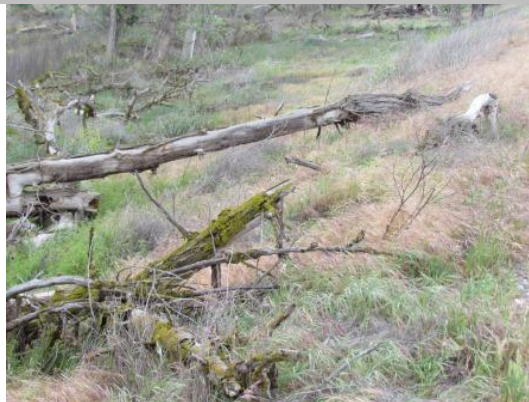
Photo 1 of 1 : phillips\_s\_20140428\_05805.jpg

This tree has not been removed since last inspection. Photo taken 4-24-2014.

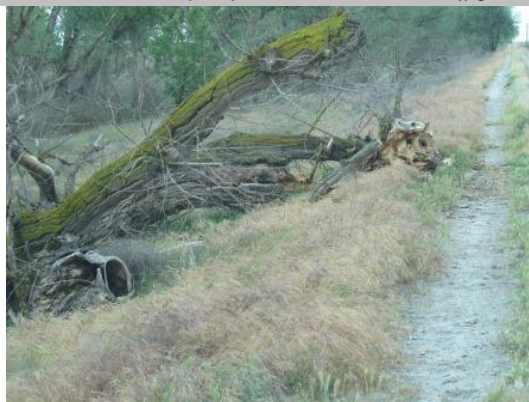
Photo 1 of 1 : phillips\_s\_20140428\_05810.jpg

A large cottonwood tree has fallen down across levee slope and shoulder should be removed from levee section.

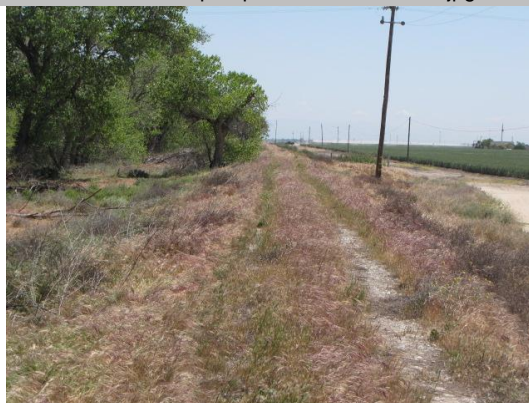
Photo 1 of 1 : phillips\_s\_20140414\_692.jpg

There hasn't been any maintenance done on this levee section since my last two inspections Fall 2012. This photo was taken 4-16-2013.

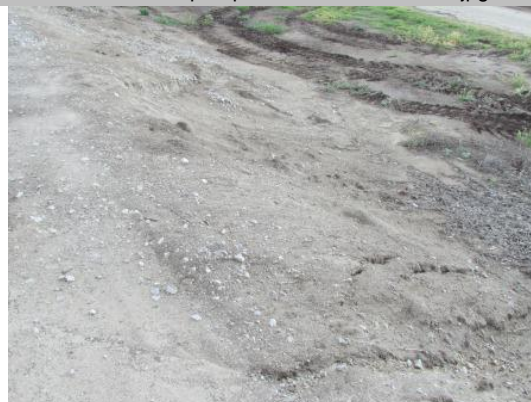
Photo 1 of 2 : phillips\_s\_20140428\_05804.jpg

Levee mile 1.51 levee damaged by the landowner. Photo taken 4-24-2014.

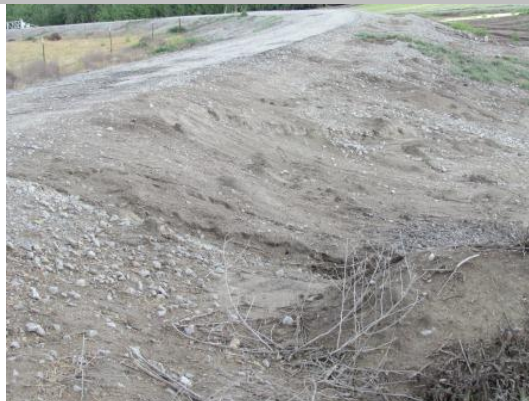
Photo 2 of 2 : phillips\_s\_20140428\_05803.jpg

Levee mile 1.51 landward slope remains unrepaired by the landowner.  
Photo taken 4-24-2014.

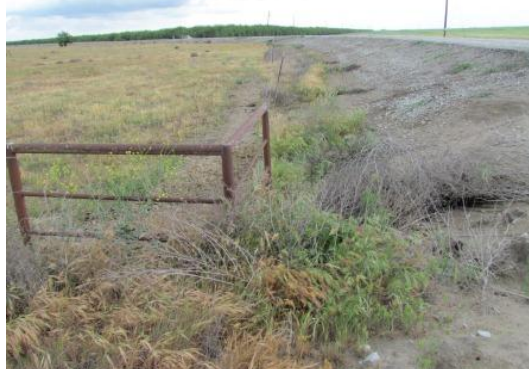
Photo 1 of 1 : phillips\_s\_20140428\_05800.jpg

Fence within the 10-foot of levee toe. This encroachment was recorded on 11-01-2012. Photo was taken 4-24-2014.

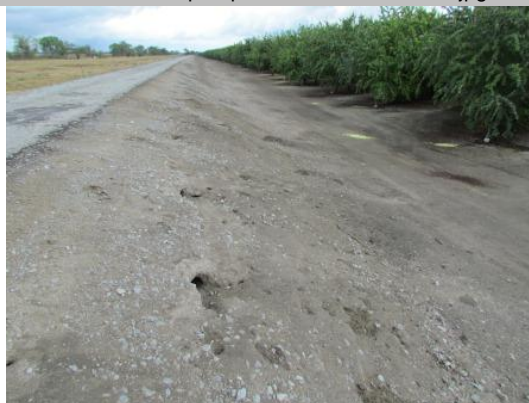
Photo 1 of 1 : phillips\_s\_20140428\_05801.jpg

There are several rodent holes covering the landward slope. Photo taken 4-24-2014.

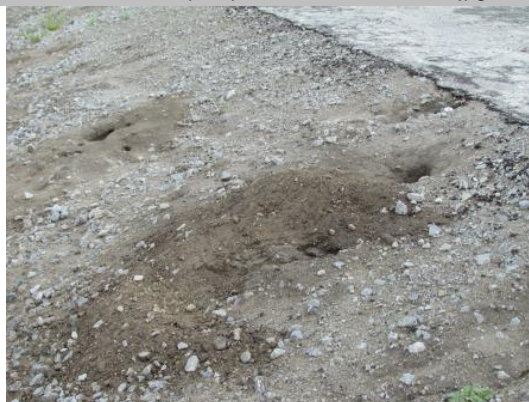
Photo 1 of 1 : phillips\_s\_20140428\_05802.jpg

Rodent activity on the landside levee slope. Photo taken 4-24-2014.

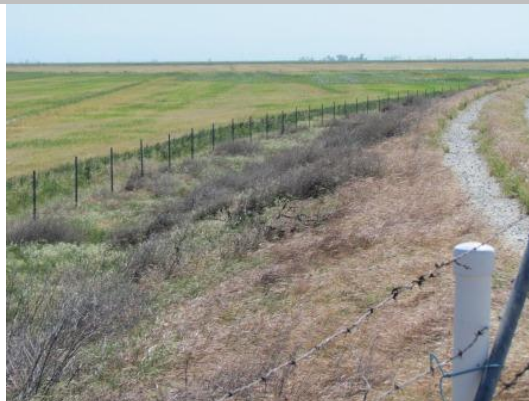
Photo 1 of 1 : phillips\_s\_20140515\_05877.jpg

Fresno River Unit 5 looking downstream at landward slope covered with wild growth. Still no maintenance from the flood control agency. Photo taken 4-24-2014.

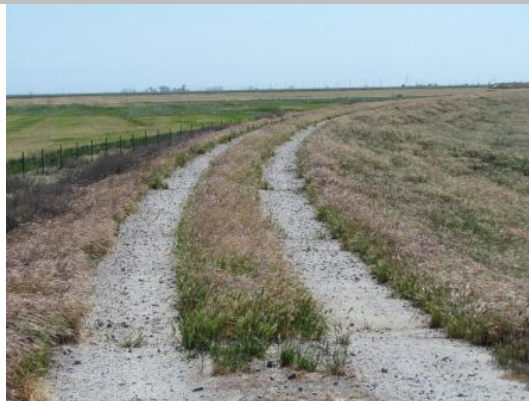
Photo 1 of 1 : phillips\_s\_20140515\_05878.jpg

Looking downstream at crownroadway from levee mile 0.01. Crown should be kept clean. Photo taken 4-24-2014.

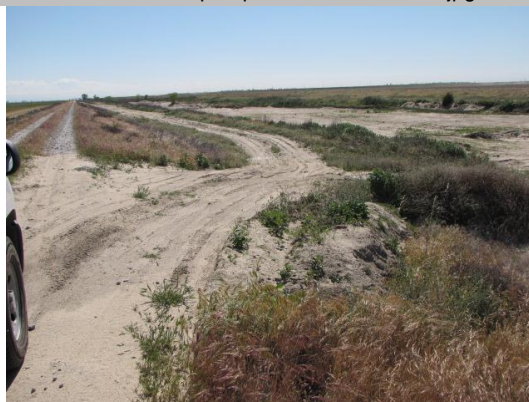
Photo 1 of 1 : phillips\_s\_20140414\_698.jpg

Ramp placed on waterward slope levee mile 1.23 to levee mile 1.48.  
Photo taken 4-16-2013.

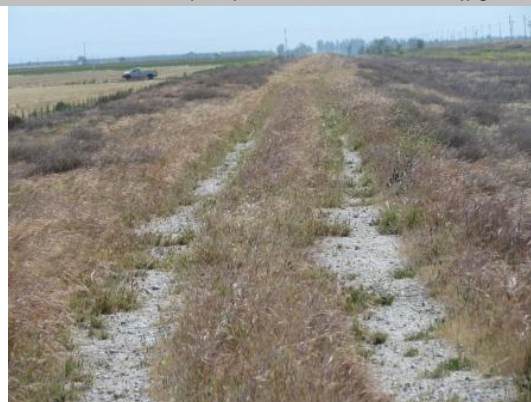
Photo 1 of 1 : phillips\_s\_20140515\_05879.jpg

Looking downstream from levee mile 2.57-4.09. Crown completely covered with vegetation. Photo taken 4-24-2014.

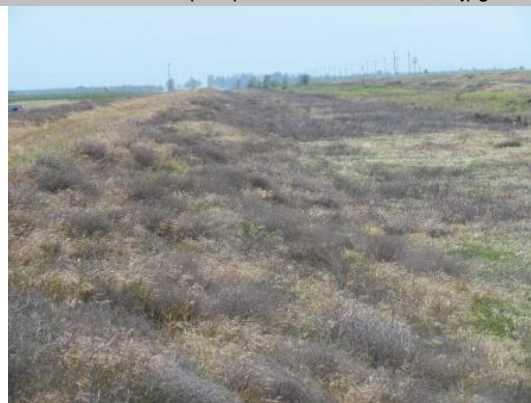
Photo 1 of 1 : phillips\_s\_20140515\_05880.jpg

Wild growth of weeds completely blocks visibility of waterside slope. Photo taken 4-24-2014.

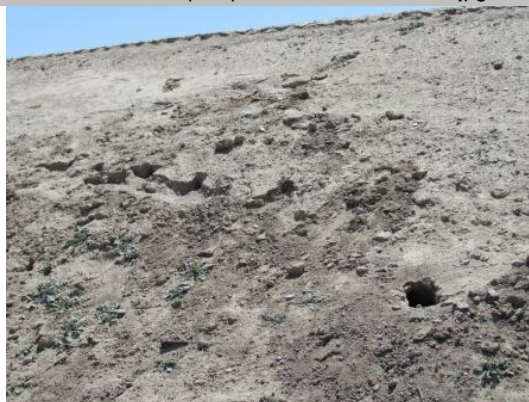
Photo 1 of 2 : phillips\_s\_20140515\_05884.jpg

Fresno River landside slope rodent activity on slope and toe. Photo taken 4-24-2014. No bait stations in place.

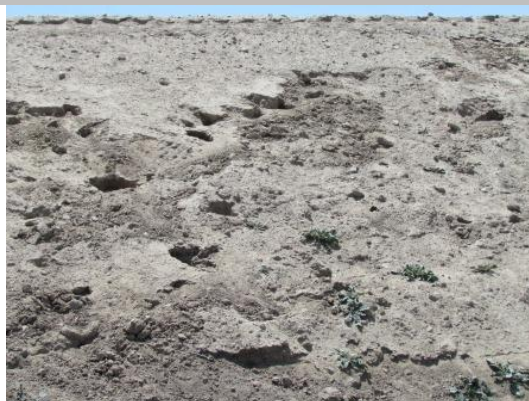
Photo 2 of 2 : phillips\_s\_20140515\_05881.jpg

Fresno River landside slope there is still a problem with rodents. Photo taken 4-24-2014.

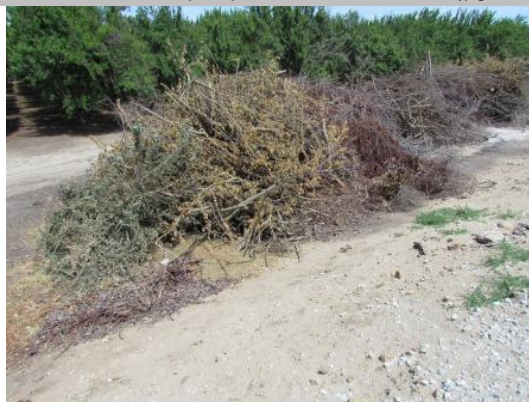
Photo 1 of 1 : phillips\_s\_20140515\_05882.jpg

Tree prunings on levee toe. Rodents are burrowing under the piles.  
Photo taken 4-24-2014.

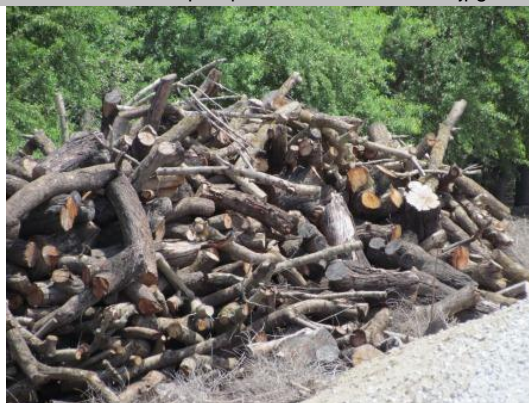
Photo 1 of 1 : phillips\_s\_20140515\_05883.jpg

Fire wood against landside levee toe. Photo taken 4-24-2014.

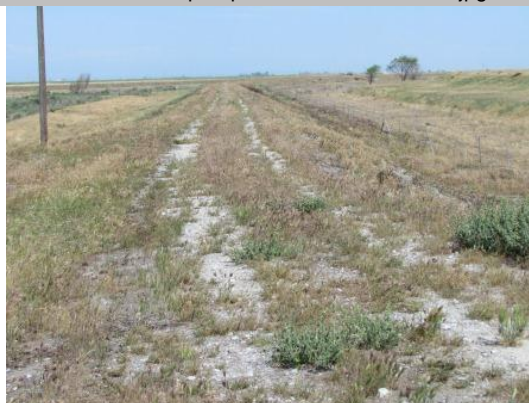
Photo 1 of 1 : phillips\_s\_20140519\_05885.jpg

Fresno River Unit 6 looking upstream from levee mile 0.00. Overgrown crown roadway. Photo taken 4-24-2014.

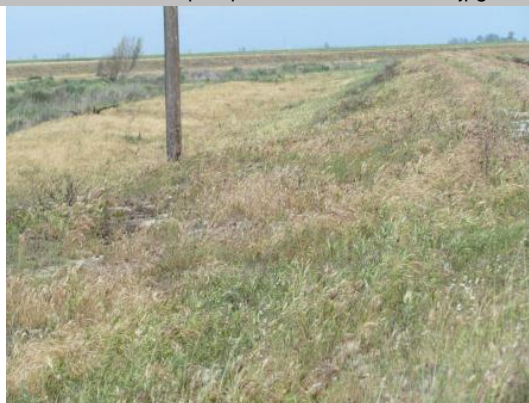
Photo 1 of 1 : phillips\_s\_20140519\_05887.jpg

Fresno River Unit 6 looking upstream from levee mile 0.00 wild growth on the water side shoulder and slope. Photo taken 4-24-2014.

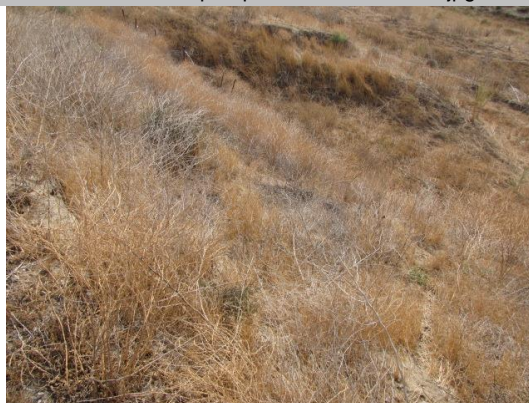
Photo 1 of 1 : phillips\_s\_20140414\_704.jpg

Erosion at levee toe. Previous Photo taken 10-31-2012. No change at this site, no new photo was taken 4-24-2014.

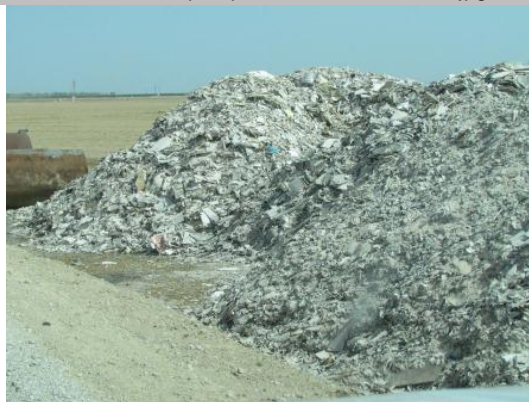
Photo 1 of 1 : phillips\_s\_20140519\_05888.jpg

Fresno River Unit 6 Levee mile 1.08-1.12, busted up recycled sheet rock stores within the 10-foot easement of the landside levee toe. Photo taken 4-24-2014.

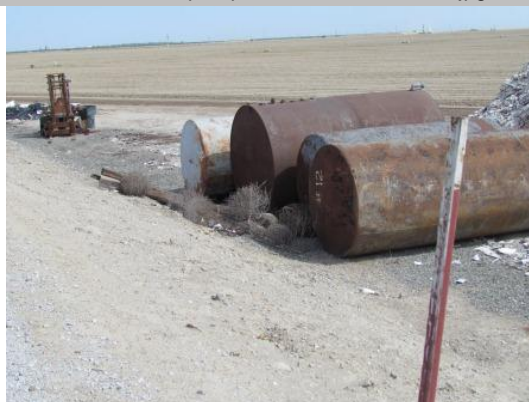
Photo 1 of 1 : phillips\_s\_20140519\_05886.jpg

Metal storage tanks on landside within 10-foot of levee toe. Photo taken 4-24-2014.

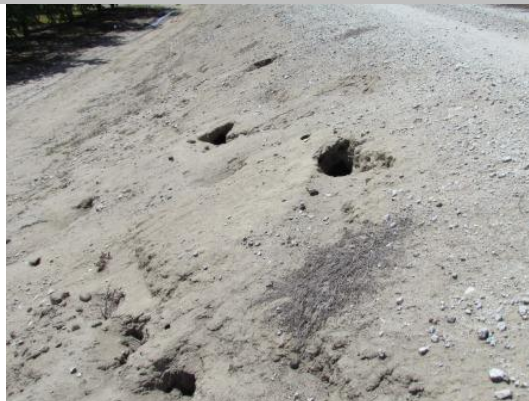
Photo 1 of 2 : phillips\_s\_20140519\_05890.jpg

Viewed from sevee shoulder landward. Photo taken 4-24-2014.

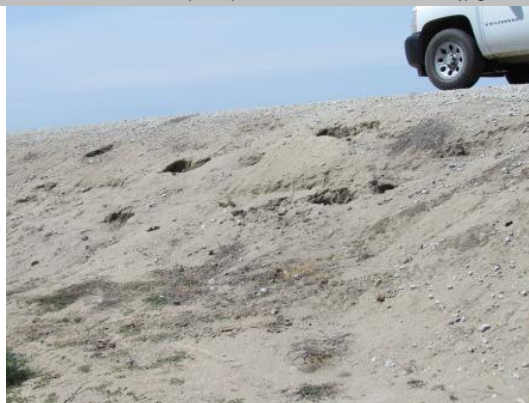
Photo 2 of 2 : phillips\_s\_20140519\_05891.jpg

Rodents very active at this location. Photo taken 4-24-2014.

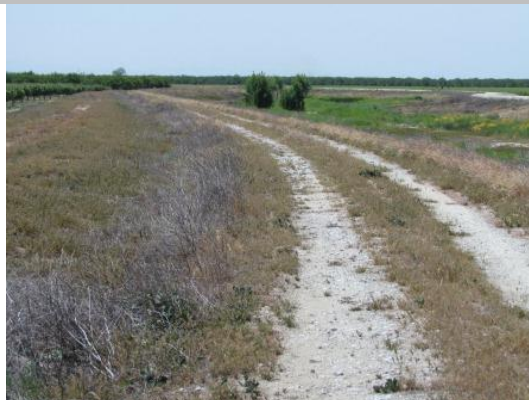
Photo 1 of 1 : phillips\_s\_20140519\_05889.jpg

Fresno River Unit 6 looking upstream from levee mile crown roadway overgrown. Photo taken 4-24-2014.

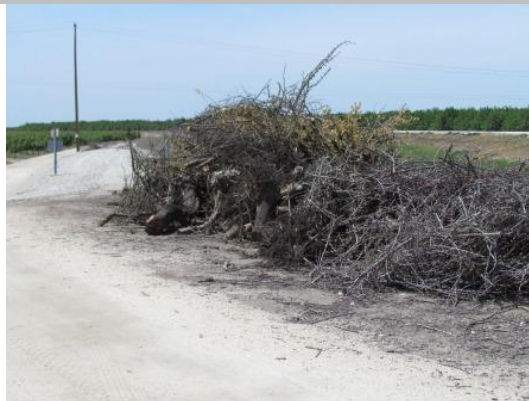
Photo 1 of 1 : phillips\_s\_20140519\_05892.jpg

Tree trimmings and cut up trees stockpiled on levee crown roadway.  
Photo taken 4-24-2014.
